100 & 300 AREA UNIT MANAGER MEETING MINUTES

Groundwater and Source Operable Units; Facility Deactivation, Decontamination, Decommission, and Demolition (D4); Interim Safe Storage (ISS); Field Remediation (FR); Mission Completion; and 100-K Sludge Treatment Project and 100-K Facility Demolition and Soil Remediation projects

November 8, 2012

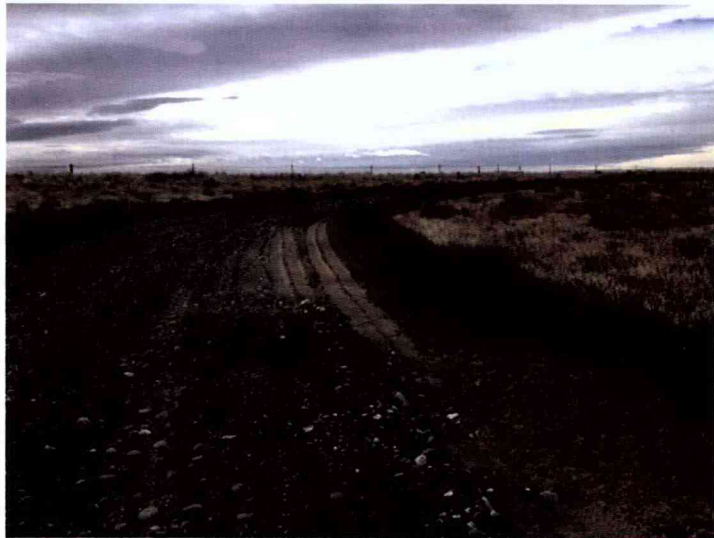
- KR4 Monthly Monitoring: The monthly monitoring of the KR4 Pump and Treat system was conducted October 19, 2012. Participants included Yakama Nation, Nez Perce Tribe, Wanapum representatives. In one location tire tracks were observed in the dirt adjacent to the gravel road (see the attached photograph, near K-116A). The tracks were within the previously disturbed area inside of the row of tumbleweeds. The consensus among participants was that the incident should be noted but it did not seem to require corrective action.

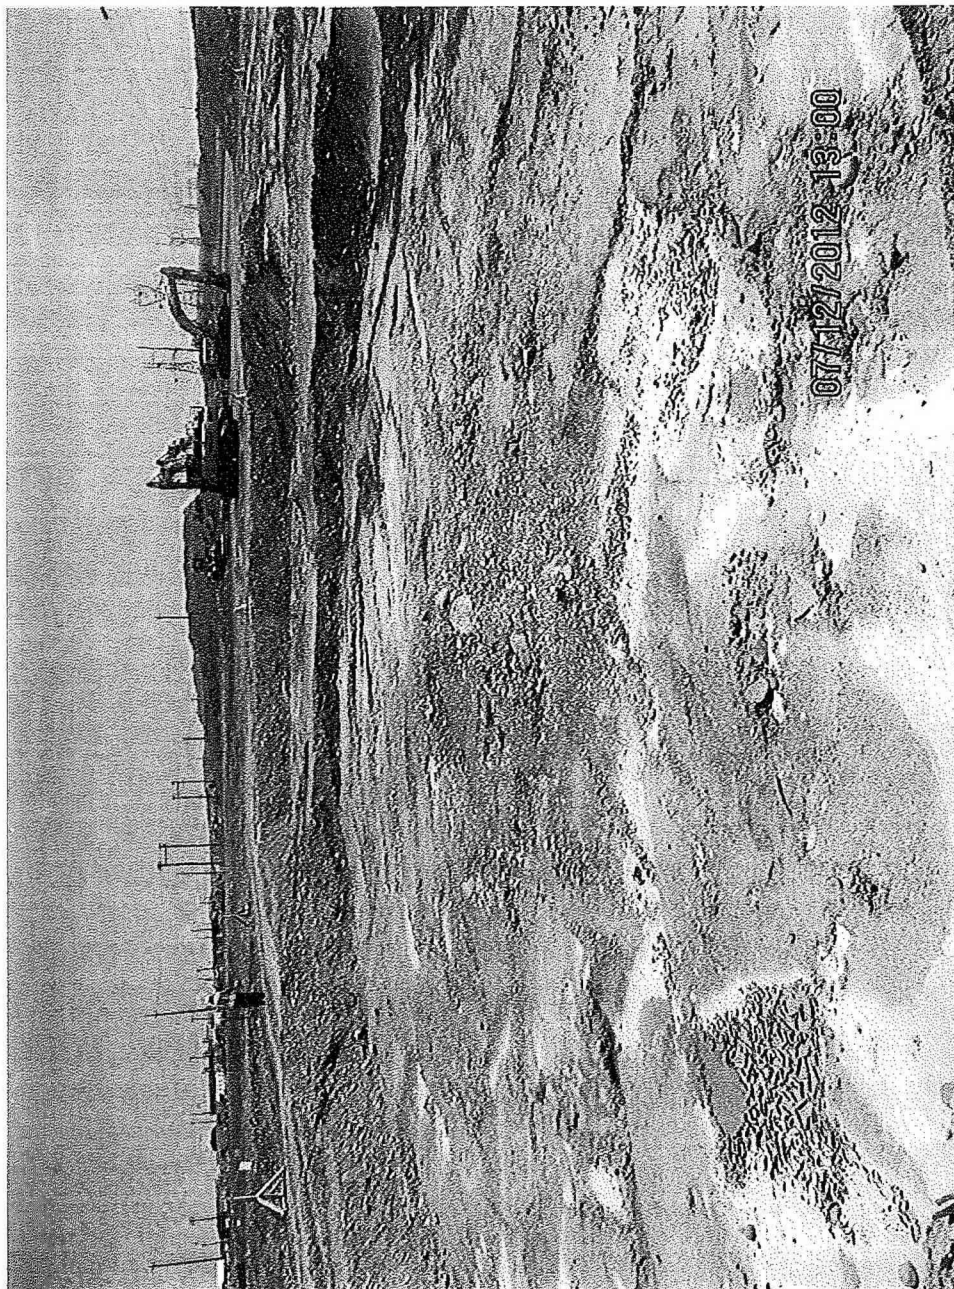
1900-N Tanks Pads Removal Visual Inspection Photographs

1900-N Excavation Looking West (view from Southeast tank ring excavation to Southwest excavation)

1900-N Excavation Looking West (view from Northeast tank ring excavation to Northwest excavation)

1900-N Excavation Looking East (view from Northwest tank ring excavation to Northeast excavation)

1900-N Excavation Looking South-Southwest (view from Southwest tank ring excavation)
